PowerSpout TRG Installation Case Study

This case study outlines the process of ordering, installing and commissioning a multi-turbine hydro site for domestic grid-connected power.

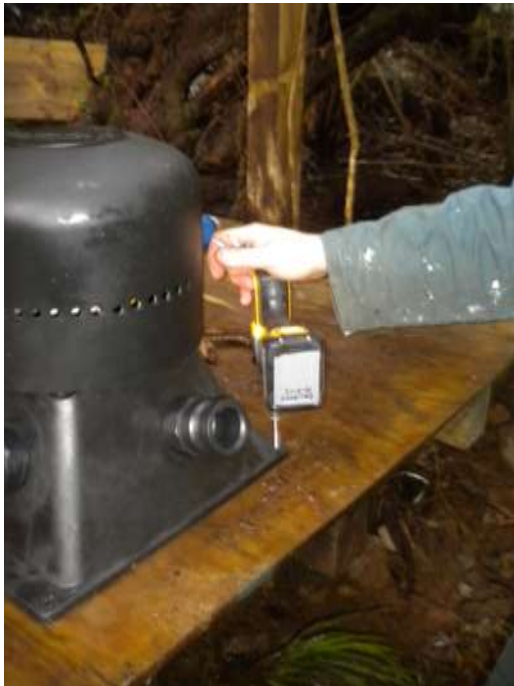
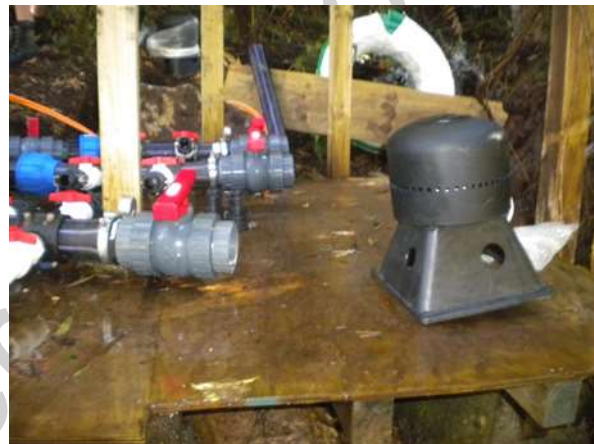
Prior to arrival the client had installed all the pipe work, a timber frame and plywood base as shown.

The 3 turbines were positioned such that the fixing tech screws would screw into the timber frame not just the plywood top. These positions were marked and a battery operated jigsaw used to cut out the water exhaust openings.

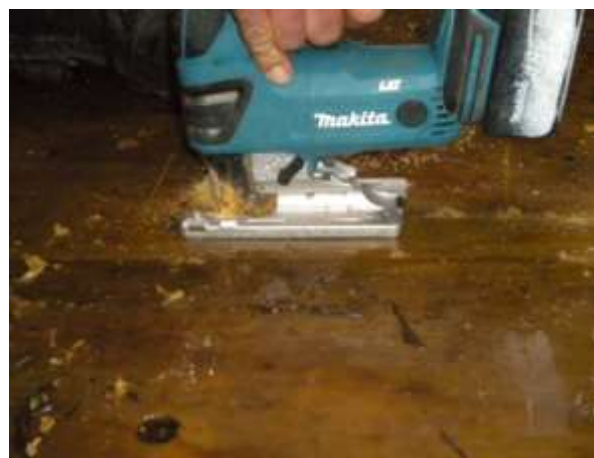
With each turbine upside-down:

- Liberally grease all threads on all fittings.
- Tighten the 4 jets sleeves to the cam-lock fittings until snug; use a large pair of channel-lock pliers as shown.
- Fit the jets and hand-tighten the black jet caps.

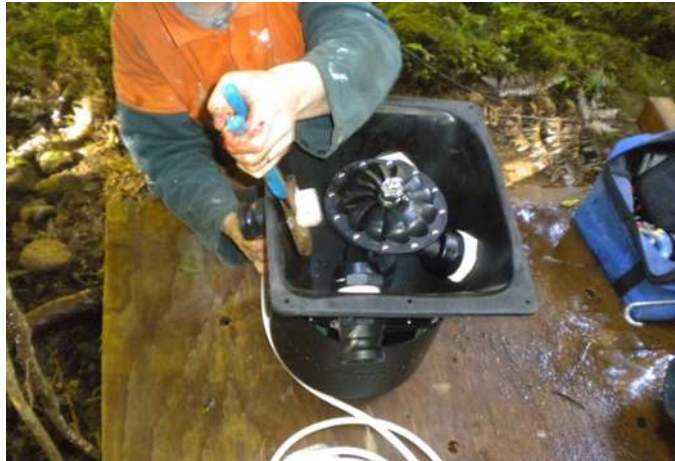
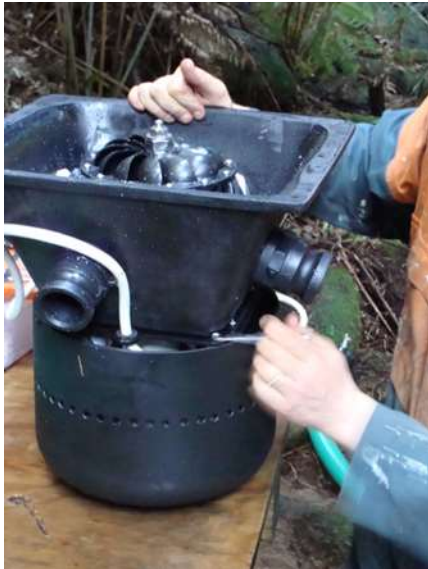
Loosen the 4 x M6 bolts so that the protective top fairing can be removed. To remove rotate the fairing relative to the base while pressing at the fixing position. Some practice is needed and it is easier to do with the turbine upside down as shown.

Sit the turbine on its base with the fairing removed.

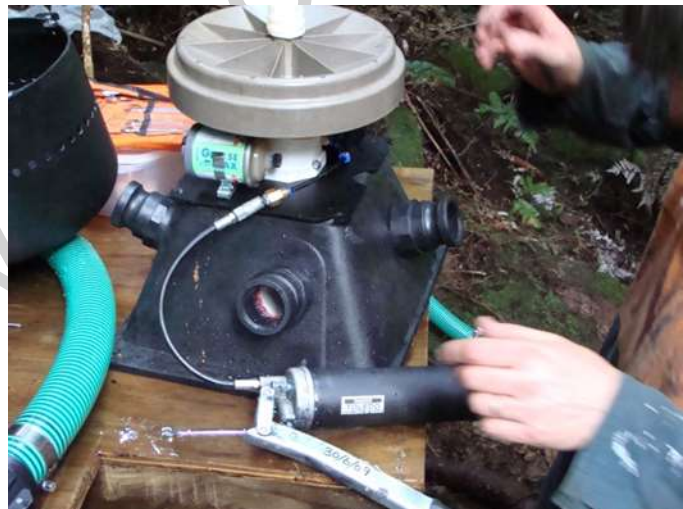
Attach a grease gun to the grease nipple on the grease tube as shown. Charge with grease: normally about 20-30 pumps will fill the bearing cavity with an initial grease charge.

Once complete remove the brass grease fitting and nipple from the grease line by pressing in the blue release collar while at the same time pulling on the fitting. Separate the grease nipple from the brass fitting.

Remove the automatic grease can from the holder clip (if fitted) and activate. It is activated by turning the grey cap until you hear the canister pop. There are detailed instructions on the canister to assist you if needed.

Once activated screw the brass fitting onto the thread of the grease canister (remove the black dust cap first). Clip the grease canister back into position and press the grease tube into position so the grease will flow automatically.

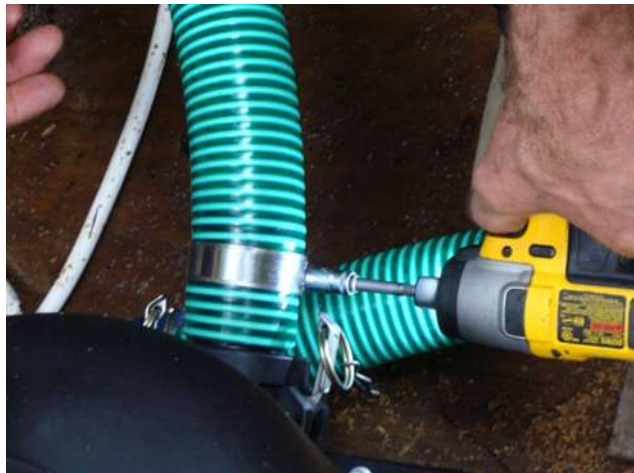
Attach one end of the 50mm (2") flexible hose as shown. This hose and pipe clamp are not supplied with the turbine; it can be purchased locally. The cam-lock fitting and valves are supplied with the turbine.

In cold climates placing the end of the hose in a bucket of hot water and liberally greasing the fittings will assist you. If you are still unable to push the fittings into the tube then a large wooden mallet will be needed.

The flexible pipes need to be rated for up to 30m of water head (up to 40m of head if you are running at maximum rated head and 33% pipe friction loss).

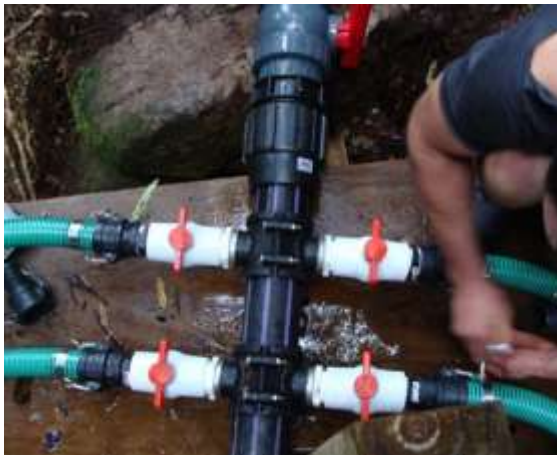
Tighten the pipe clamp with a drill and socket as shown.

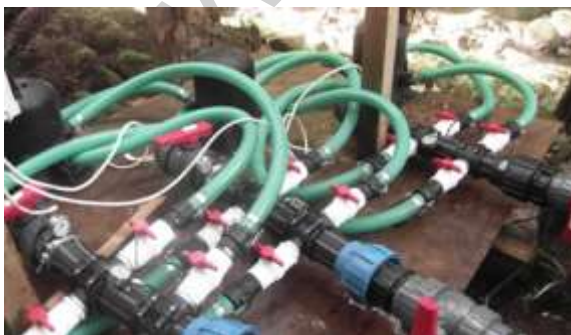
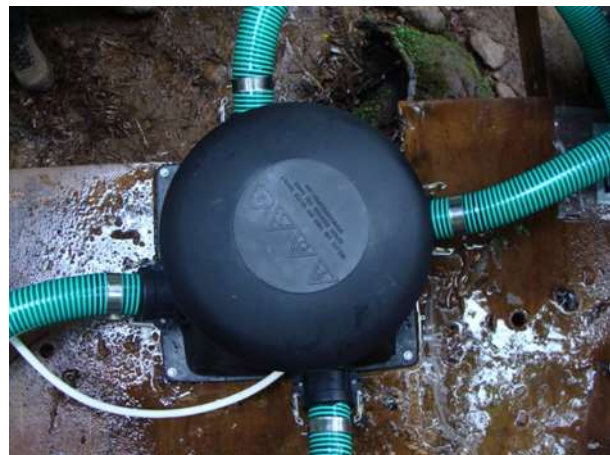
Cut the flexible pipe to length and then attach to the cam-lock fitting that connects to your larger supply pipe.

Note the valves (supplied) are located on the supply pipe end and not at the turbines. This allows the turbine to be easily removed for servicing.

Once all 4 flexible pipes have been cut and connected it will look like these pictures.

Once complete it should look like this. Note the white power leads are yet to be put in protective conduit as required at this supply voltage.

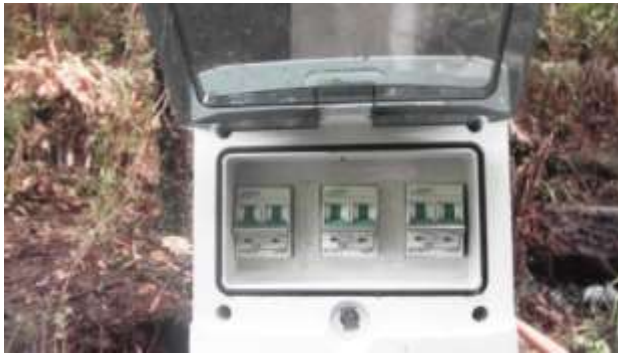
Connect each turbine to the main supply cable via a 2 pole DC breaker of the correct amp and voltage rating as shown. If outside, these breakers must be in a UV resistant waterproof housing and comply with local wiring rules.

Ensure each turbine is connected to a permanent and reliable ground connection that complies with local wiring rules.

- Use a volt meter to confirm the OCV (open circuit voltage) of each turbine in turn.

In this case we recorded about 360 +/-20 VDC. Differences of +/- 8% between turbines is fine since they will not all be identical.

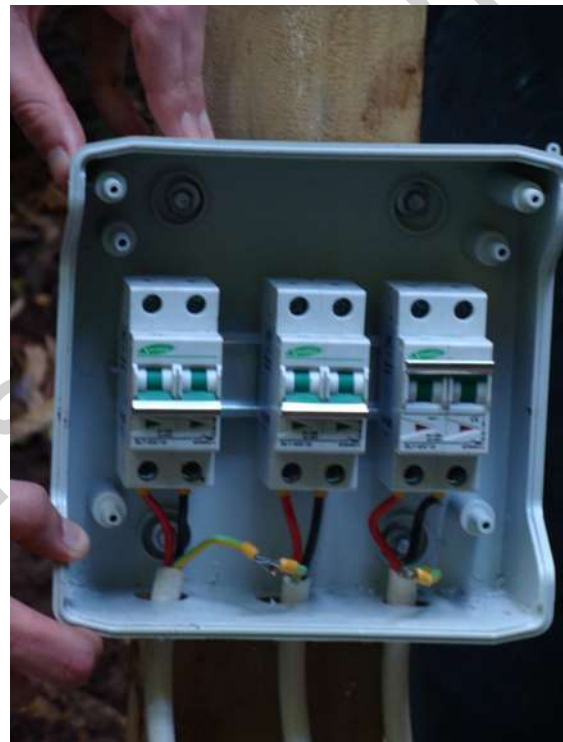
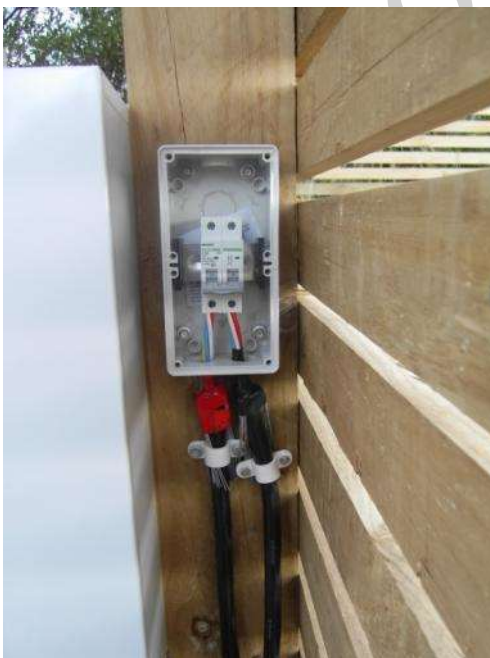
Connect the main supply cable via a 2-pole DC breaker of the correct amp and voltage rating as shown. If outside these breakers must be in a UV resistant waterproof housing and comply with local wiring rules.

This picture shows a temporary connection so that the turbine installer can check correct operation of the turbines prior to the electrician making permanent code-compliant waterproof connections.

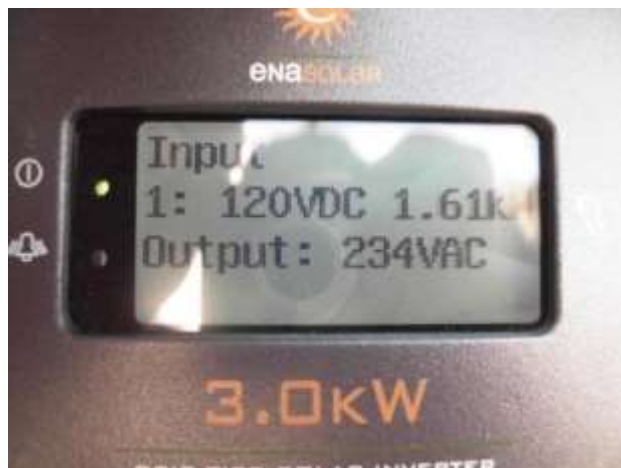
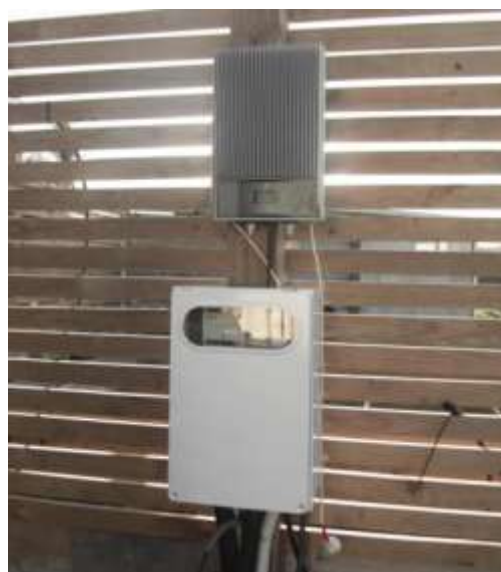
The picture to the right shows an EnaSolar 3kW inverter installed above home meter box.

There is a temporary connection via an extension lead to the home AC supply for system testing. The electrician will make permanent code-compliant connections once correct operation has been confirmed by the hydro turbine installer.

The inverter when connected tracked down from 360 OCV to 120 VDC. Peak power was noted to be 1.61 kW at 120 VDC cable voltage, 15% lower than the calculated 1.89 kW.

The reason for this 15% difference is due to a number of installation issues that can mostly be corrected.

Cable voltage is too low and at the bottom end of the inverter operating range, so the cable and inverter losses are higher. This can be corrected by installing the correct Smart Drive PMA stator for the 14.1m head at this site.

At 120 VDC the loss in the cable is 100 W more than calculated at 180 VDC, so correcting this will lift generation to 1.71kW.

Installing a new PMA stator (for the site head) will lift the OCV from 360 to 500-550 VDC and the MPPV would increase to about 180 VDC. Note the inverter has a maximum input rating of 600 VDC which must not be exceeded. The head may increase by 1 m in floods so staying under 550 VDC is advisable.

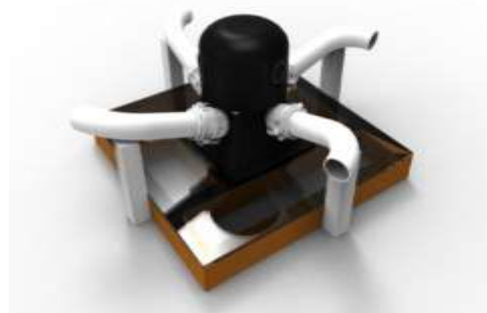
The other issue is that the flexible pipes have not been correctly supported, which can lead to jet misalignment. Correcting this can result in 1-5% improvement in output power. Losses in flexible pipes and manifold fittings increase as the head drops.

This site has a total of about 20m of 50mm ID flexible pipe that flows at 2.75l/s. Losses in this pipe are calculated at 15 W of total power.

Another common source of increased loss depends on how you connect your flexible pipe to the main supply pipe. 90 degree sharp take-offs have 2 x the loss of a 45 degree take-offs. The extra loss due to 90 degree take off is estimated at 10W.

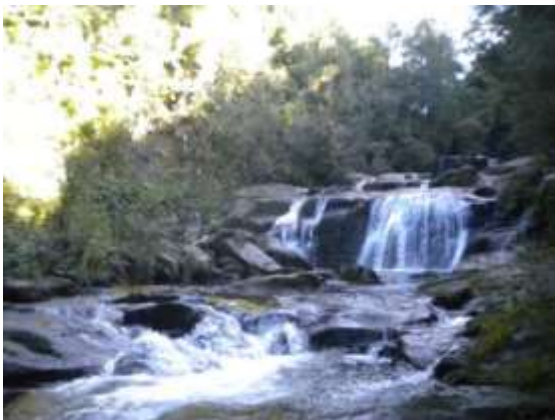
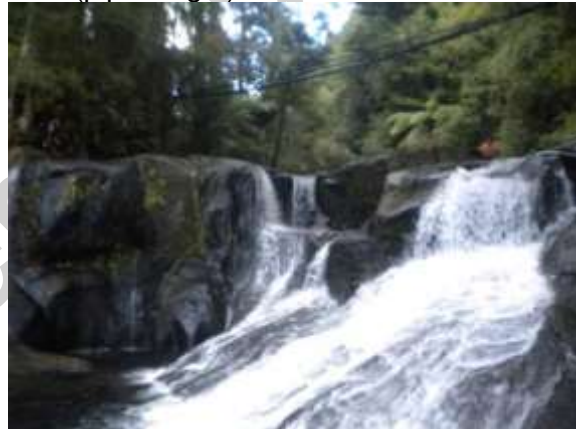
The river rapids fall 14.1m over a distance of 110m (pipe length)

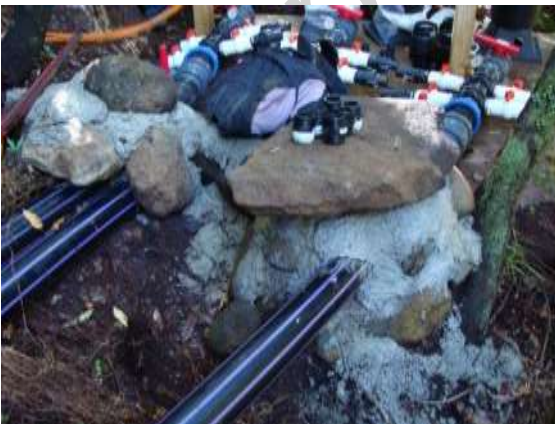
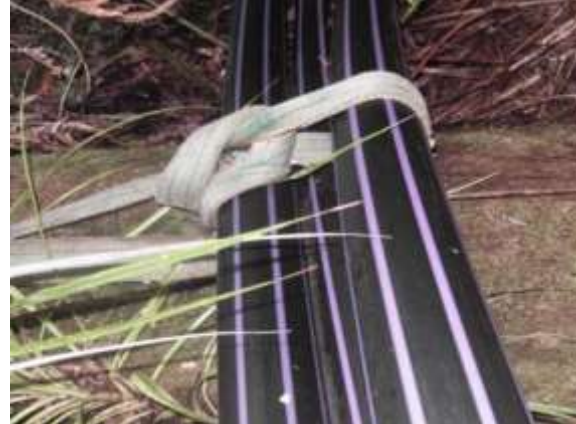
Pipe securement, concrete and ratchet tie-downs are often employed

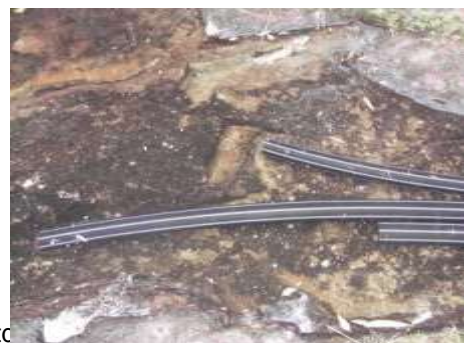
Pipe intake screens are yet to be fitted. A stainless steel mesh sock is planned for the 3 pipe intakes.

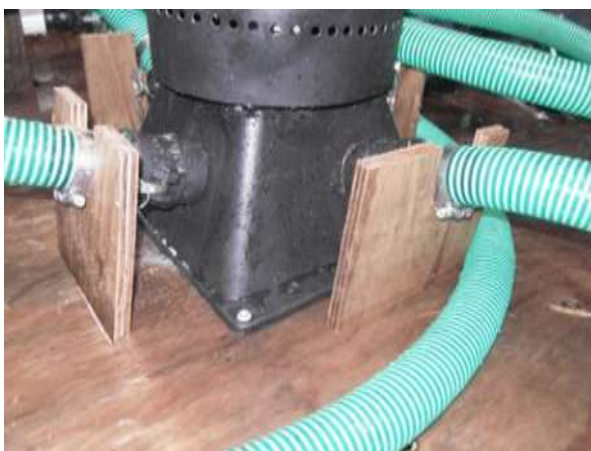
- Fitting larger (19.9mm) jets so that the running head is 67% of the static head $9.5\text{m} = 95\text{kPA}$. This means the pipe is transferring all the power it is capable of at a flow rate of 14.2 l/s.
- Installing plywood supports (cut on site) to prevent pipe weight altering jet angle.

Revised calculations indicated that the output would go up to 652 W/turbine at the input to the inverter with these changes (1.956 kW in total).

Once the changes were made the power input on the inverter display showed 1.96kW. The turbines were running exactly as predicted.

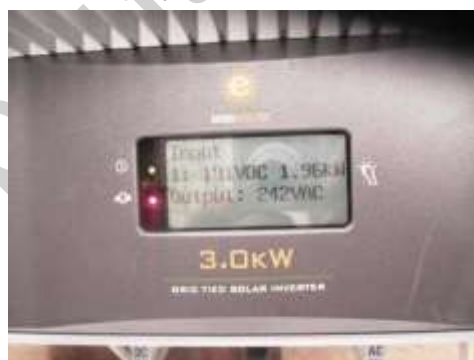
The observant reader will note the red earth fault light is on. This is because a cable was damaged during installation and the conductor is touching the earthed armour screen. The site electrician is yet to repair this damage to the cable, but when it is fixed the fault light will disappear.

Most inverters are fitted with earth fault detection: DO NOT ignore this fault warning. However, if your solar PV inverter or MPPT regulator is fitted with arc-fault detection then this should be disabled as the slight ripple of the rectified DC will often false trigger the arc detection software when there is no fault.

This is a timely reminder to check your cable for faults and have your electrician sign off that the system has been installed and tested in accordance with local codes.

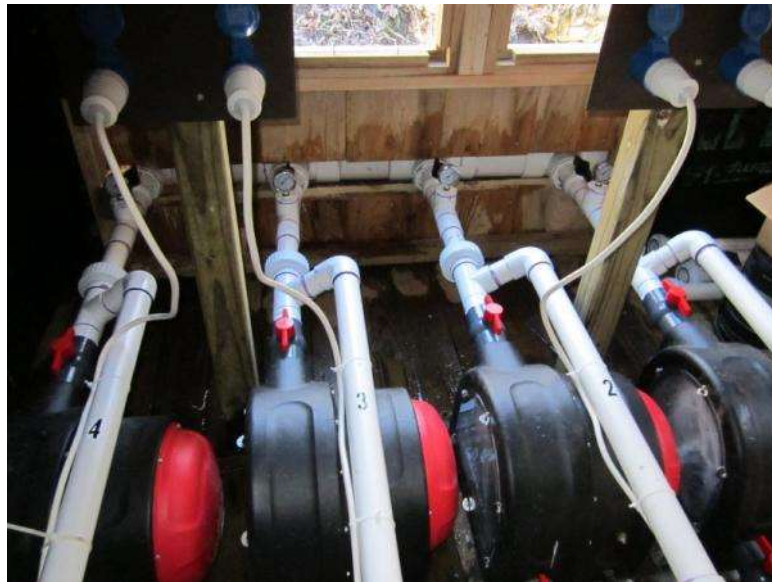
For example a 330m length of 94mm ID MDPE pipe with a 60m fall will generate 3.3 kW at 14 l/s with 4 PLT turbines fitted. This might look similar to the picture below.
